School and Institutional
TRUST LANDS ADMINISTRATION

SITE INSPECTION REPORT

Date of Inspection : April 2, 1999

The purpose of the inspection was to document mining activity since the last site inspection of June 19, 1997. See accompanying map showing areas of surface disturbance.

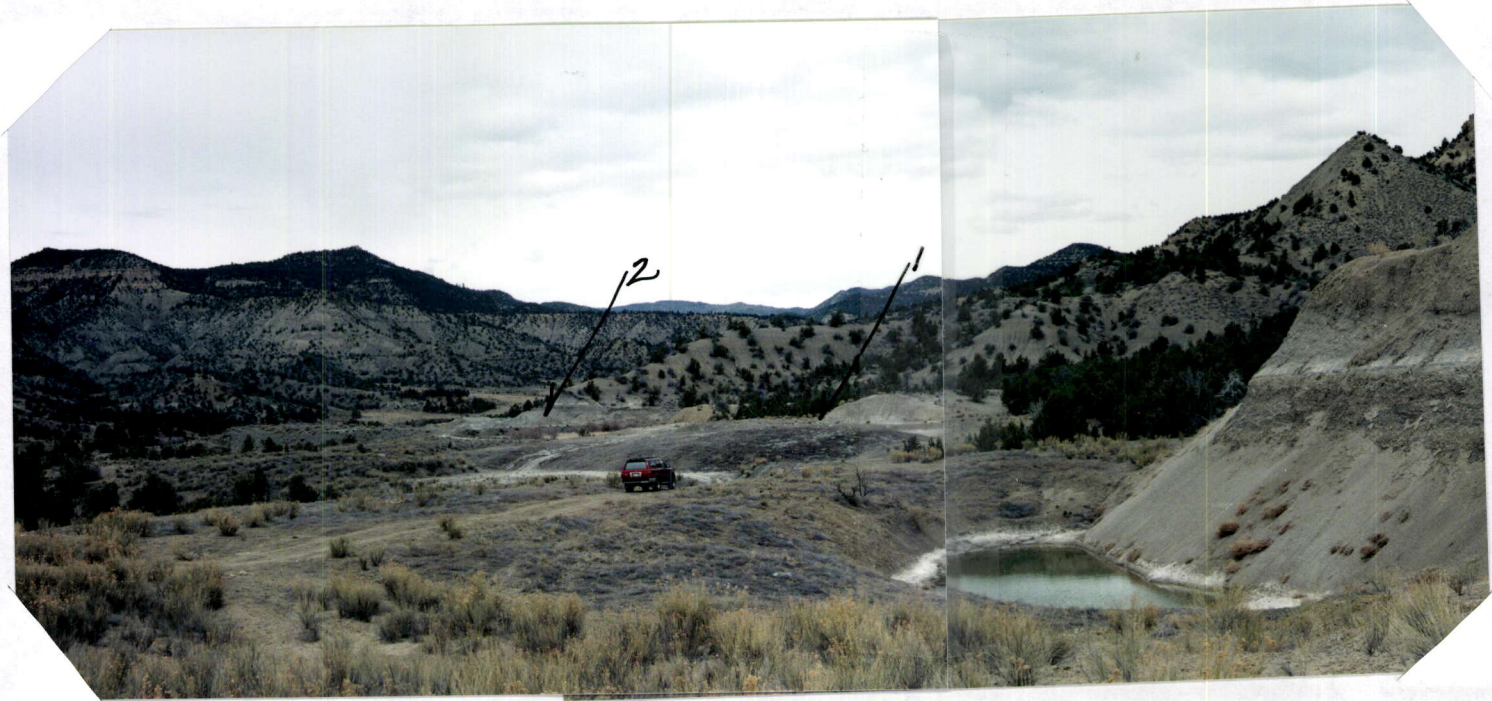
Photo # 1. Looking north from the south end of the open pit in Area 1. Note the degree of re-vegetation as compared to that of the May 10, 1996 report. Arrow # 1 shows the location of Area # 2 and arrow # 2 shows the location of Area # 3.

Area 1: There has been no additional reclamation and no new excavations at this site. Area 1 is on lands held under lease ML 41355 by Olga Berry and operated by Robert Harris. Most of this area had been graded and re-seeded in 1996 and some native vegetation has naturally invaded the area. At the time of this inspection new spring growth had just begun to emerge so it was difficult to estimate the amount of cover expected for the summer of 1999. In Area 1 there remains a small, water filled pit which was left open for future excavations. This pit is approximately 135 feet long and 60 feet wide and encompasses approximately .18 acres. Compare photo # 1 of this report with photo # 1 of the May 10, 1996 report.

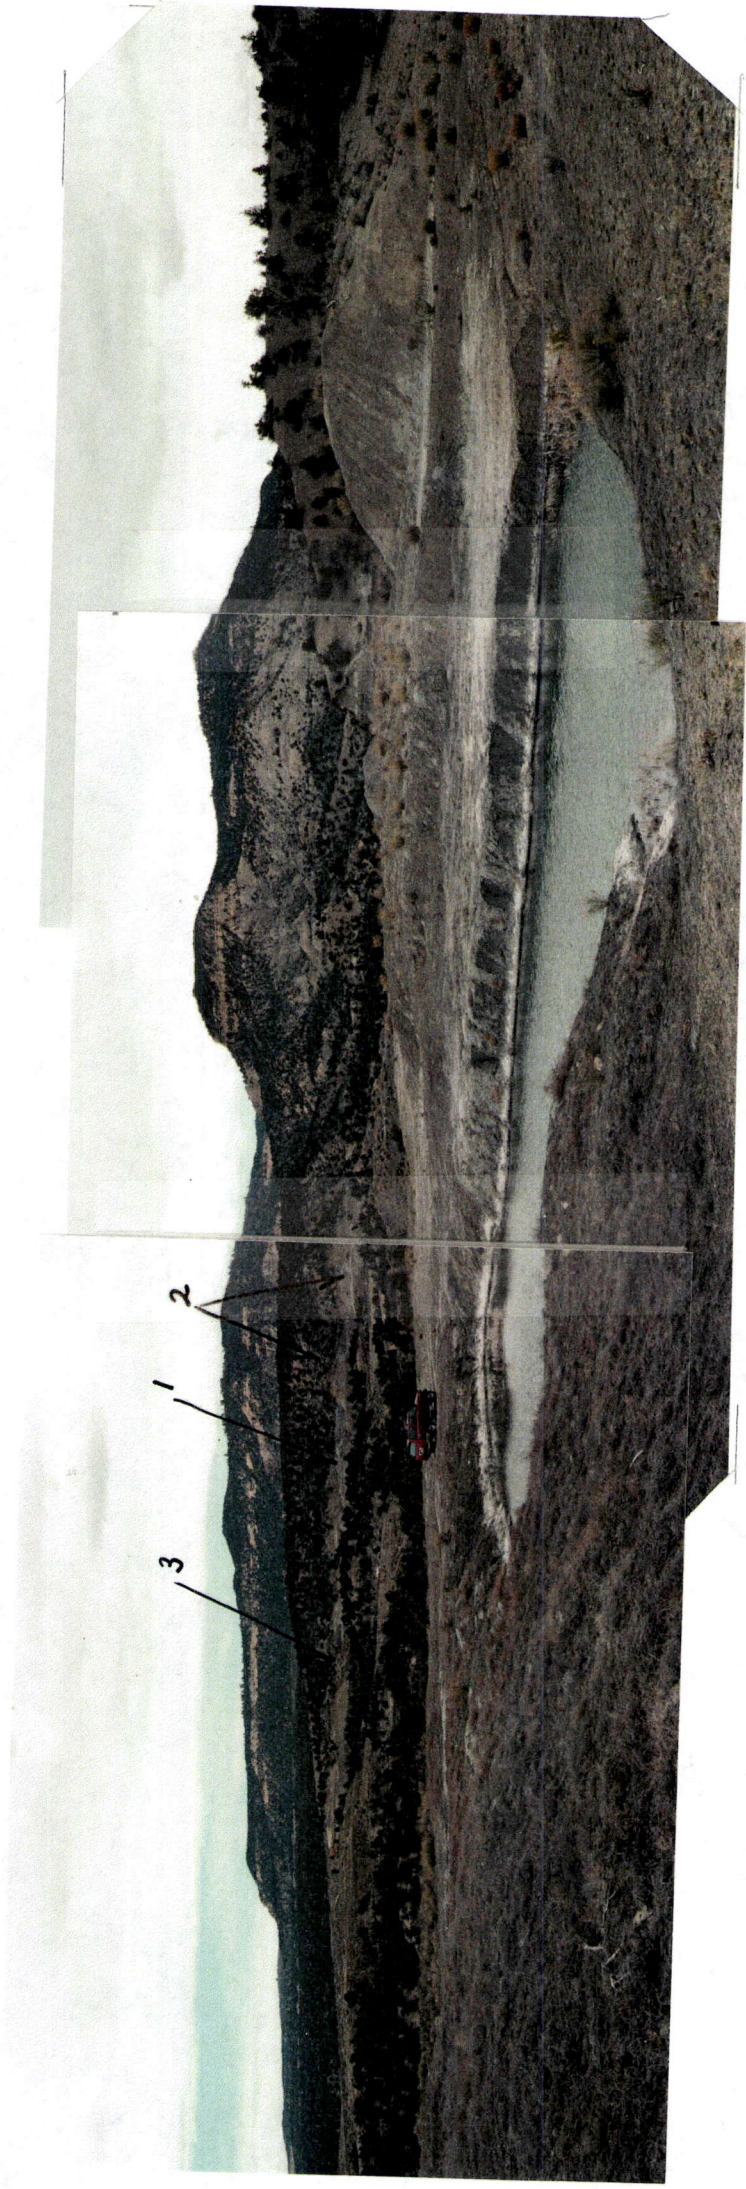
Photo # 2. Looking west from the east side of the unreclaimed pit in Area 2. Note the degree of re-vegetation as compared to that of the May 10, 1996 report. Arrow # 1 shows the locations of Areas 4 and 5. Arrow # 2 shows the location of disturbances created by Mr. Rex Harris on his unpatented mining claims located on BLM land. Arrow # 3 shows the location of new disturbances that are discussed under Area 7 of this report.

Area 2: As with Area # 1 most of Area 2 had been re-contoured and re-seeded in 1996. There also remains a water filled pit which is approximately 117 feet long and 135 feet wide, .36 acres, which was left open for future excavation. Area 2 also falls within the boundaries of lease ML 41355, held by Olga Berry. Compare photo # 2 of this report with photo # 2 of the May 10, 1996 report.

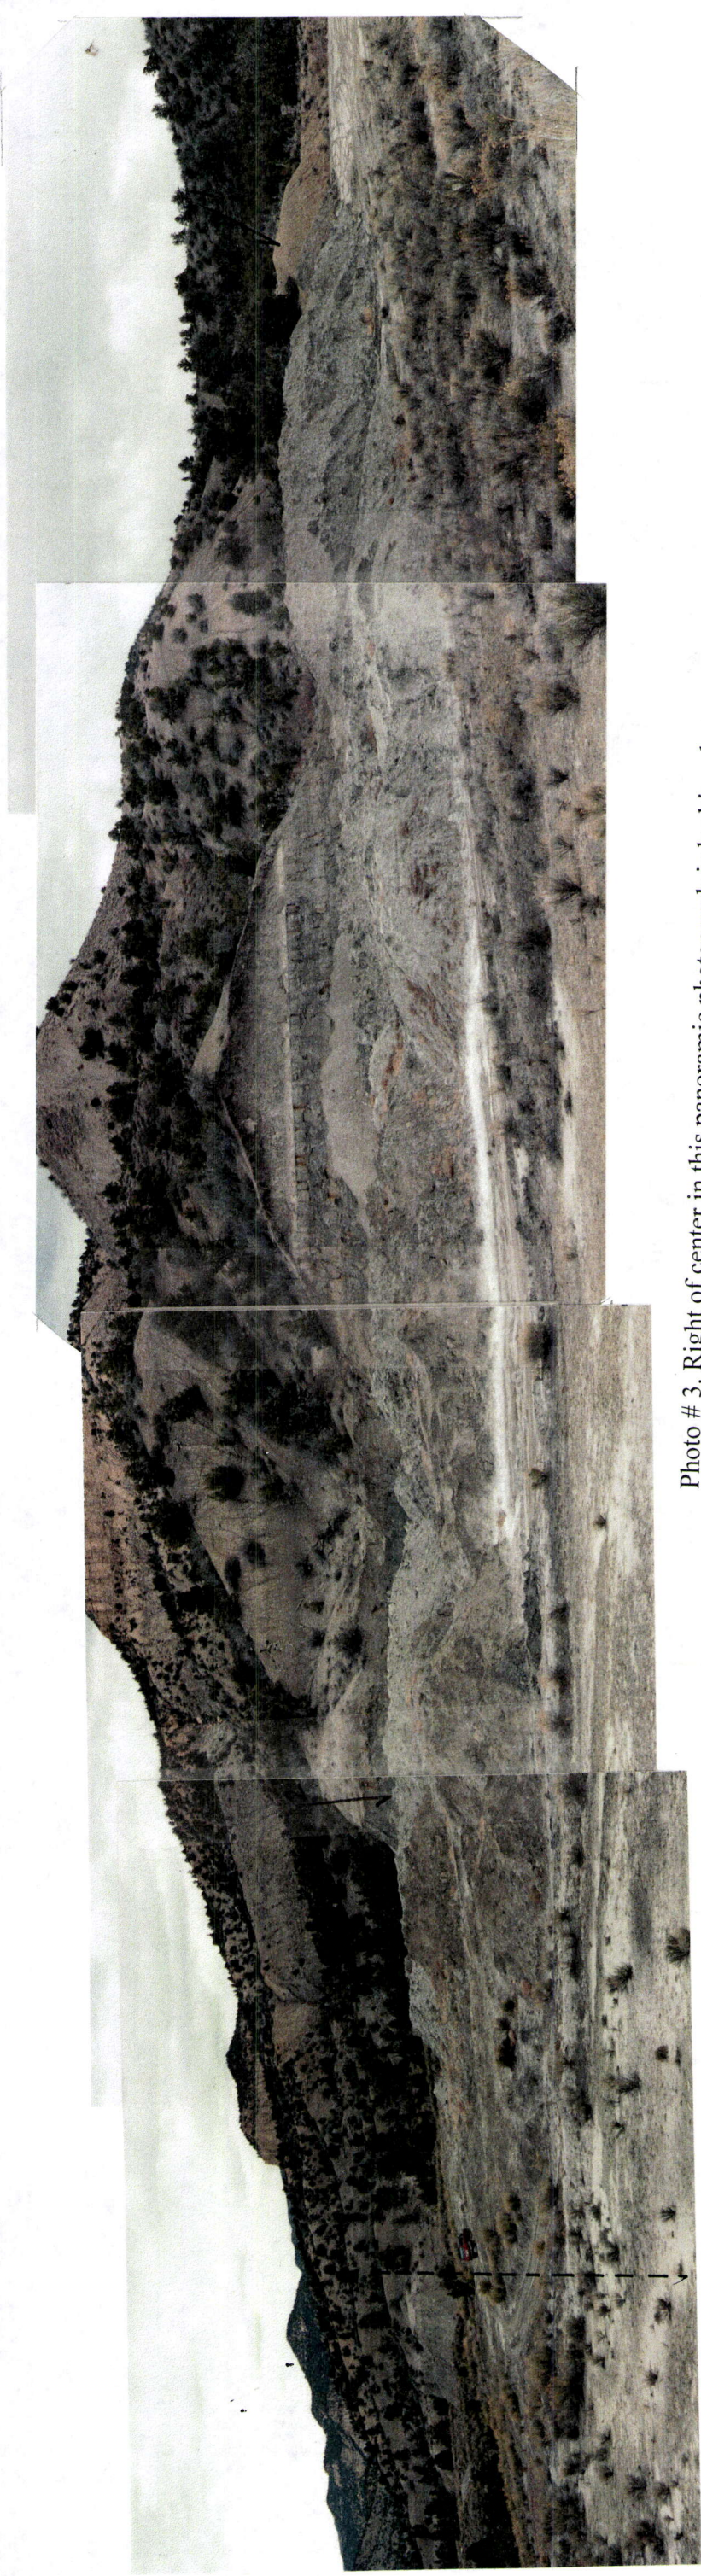
Photo # 3. Right of center in this panoramic photograph is looking due west onto reopening of the disturbance that was included as unreclaimed land in the Munson report of November 22, 1995. The far right of this photograph shows newly created disturbances when compared with a photograph taken from the same location that is included in the surface examination report of May 10, 1996. The dashed line, running north/south, represents the west boundary line of the Olga Berry lease ML 41355 and the east boundary line of the Caruso lease ML 36996. Arrow # 1 show the position from which photo # 4 of this report was taken and arrow # 2 shows the location from which photo # 5 was taken.

Area 3: In the last year there has been significant reworking and expansion of the excavation in Area 3. The old excavation that existed on the site has been deepened and expanded to the south. Originally this area was the site past mining activity that encompassed 3.27 acres of unreclaimed land (See Munson Report, November 22, 1995). The majority of the recent excavation lies within the original unreclaimed area of 3.27 acres but there has been an expansion of the excavation to the south and to the east, against the hillside, that increased the disturbance by

approximately .45 acres. Area 3 also lies within the lands encompassed by the Olga Berry lease ML 41355. Total disturbance in Area 3 is now 3.72 acres. Compare photo # 3 of this report with photo # 3 of the May 10, 1996 report. See photograph 3, 4, & 5.

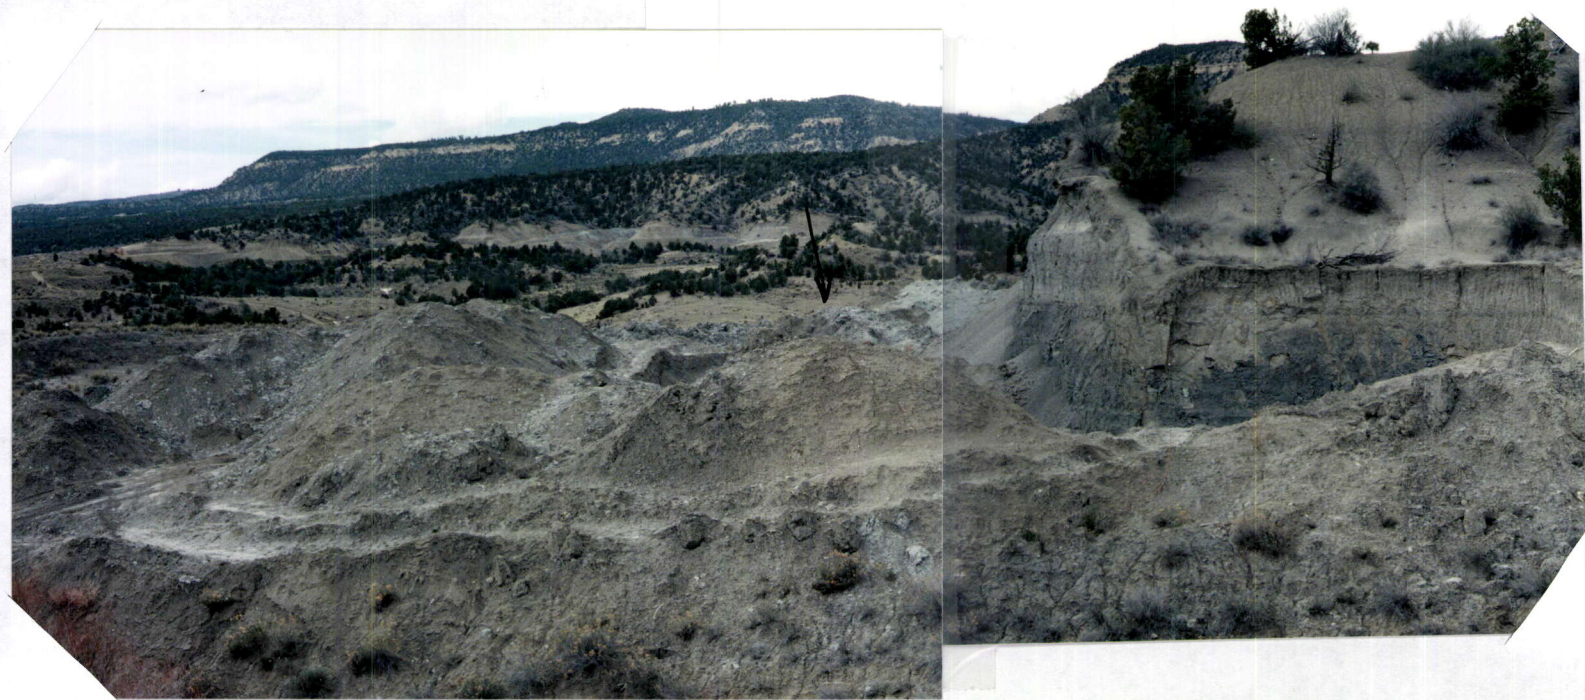
Photo # 4. Looking northwest onto recently excavated lands within Area # 3. The position from where this photo was taken is shown in photo # 3. The arrow shows the position from where photo # 5 was taken which looks back onto the position from where this photo was taken.

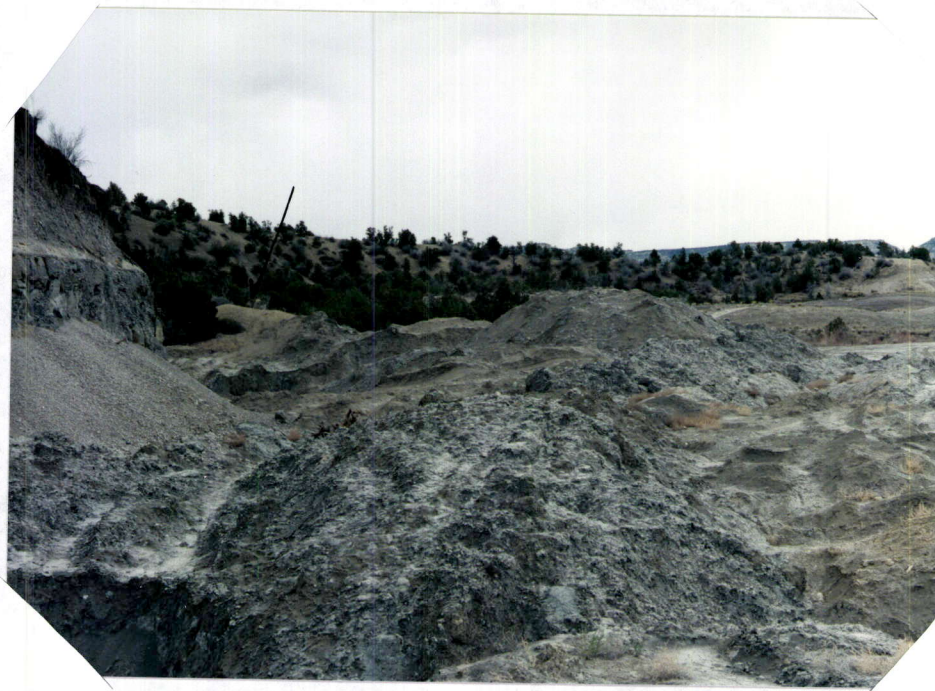
Photo # 5. Looking southeast onto the recent excavation in Area 3. The arrow shows the location from where photo # 4 was taken which looks onto the position from where this photo was taken.

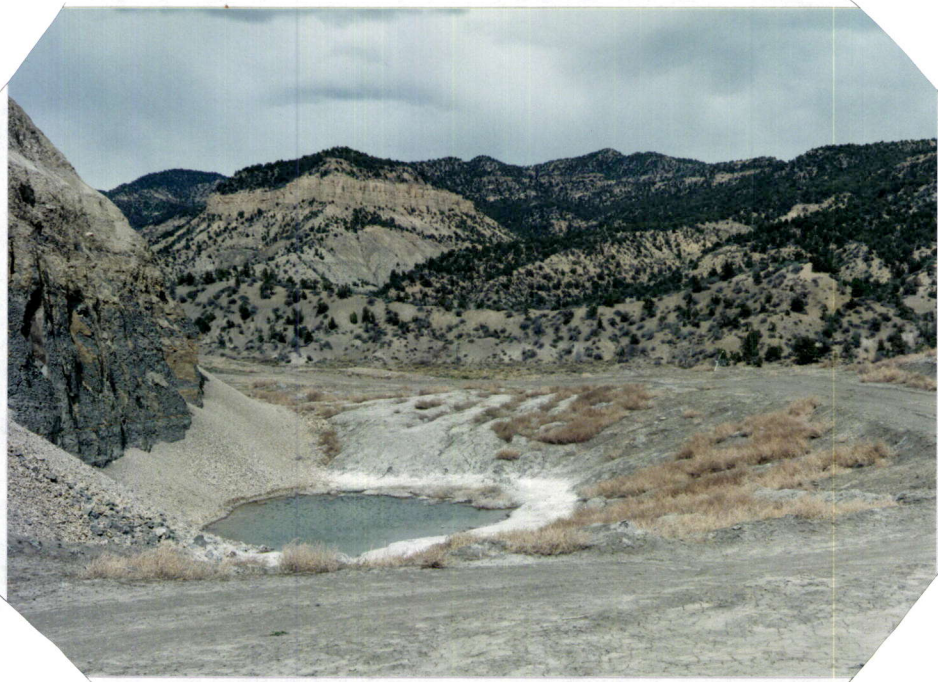
Photo # 6. Looking northeast onto Area 4 which was excavated in the summer of 1997. The waste piles around the pit area were graded and seeded. The pit was left open to allow for easy access should the lessee wish to mine the area at some future date.

Area 4: Area 4 which is located on lands leased to Olga Berry under lease ML 19890. This site was reopened and excavated in the summer of 1997 by Robert Harris who is the designated operator for Olga Berry. The condition of this site in 1996 is shown in photo # 6 of the May 10, 1996 surface examination report. After the reentry and excavation in the summer of 1997 Mr. Harris graded and seeded the surrounding waste piles and left a shallow pit to allow for future mining. The area of disturbance for Area 4 remains at .2 acres as it was in 1996. See photograph # 6.

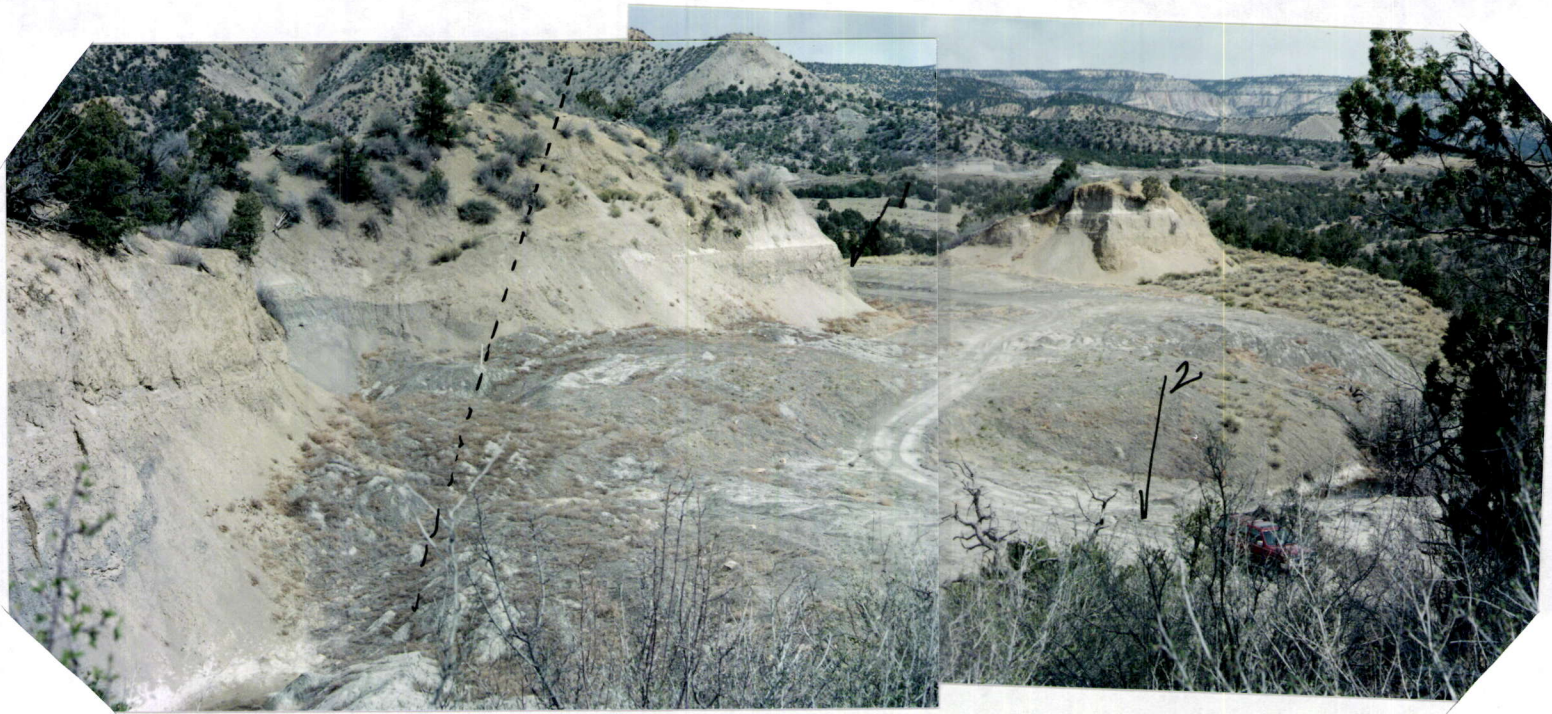
Photo # 7. Looking east from the hillside above Area 5. There appears to have been no mining activity in this area since the area was graded and seeded in 1996. The dashed line identifies the approximate position of the boundary line between the BLM land in section 25, on the left and trust lands in section 36, on the right. Arrow # 1 shows the location of Area 4 and arrow # 2 shows the road that continues to mine Area 7 of this report.

Area 5: Area 5 is adjacent to Federal, BLM land on which Mr. Rex Harris conducted mining in 1995. Mr. Harris removed nodules along the boundary between trust lands in section 36 and BLM land in section 25. In 1996 Mr. Harris regraded and seeded the disturbed lands which encompassed approximately .18 acres. At the time of this inspection it appeared that there had been no new disturbances in Area 5. See photograph # 7.

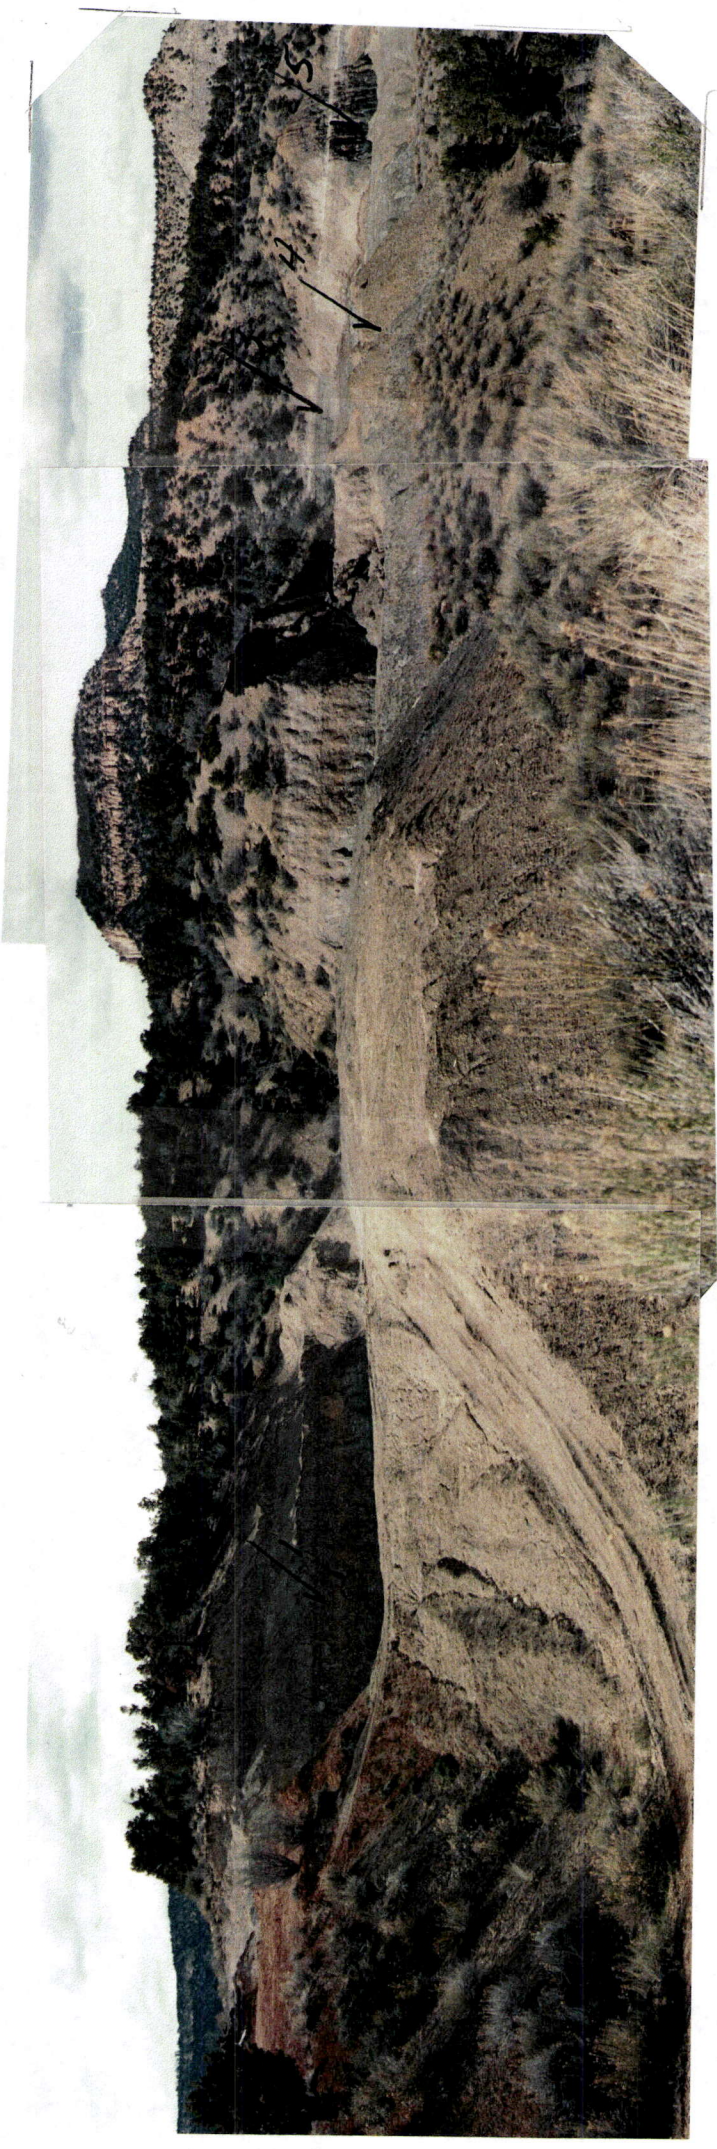
Photo # 10. Looking northwest onto the disturbance in Area 7. This photo was taken from a small point which is just east of the old road, in the left foreground, that traversed the now disturbed area. Arrow # 1 shows the high wall that is also shown by the arrow in photo # 11. Arrow 2 is the position from where photo # 11 was taken. Arrow # 3 shows the location of Area 5. Arrow # 4 shows the position of the overburden pile that is shown by the arrow in photo # 9 and arrow # 5 shows the location of Area 4. Note the large overburden pile that extends from the foreground to the location indicated by arrow # 4. The overburden pile has blocked the natural drainage along its entire length and will pond water along the entire length of the excavation in Area 7.

Area 7: Apparently in the summer of 1998 a significant area of disturbance was created in the W $\frac{1}{2}$ NE $\frac{1}{4}$ NW $\frac{1}{4}$ of section 36. The disturbed lands are part of lease ML 19890 which is held by Olga Berry and operated by Robert Harris. The excavation at Area 7 reopened and expanded an area that was considered naturally reclaimed from past mining activity. The recent excavation has created high walls of approximately 20 to 30 feet and has distributed overburden over an area of approximately 1.8 acres. Natural drainage from the hills west of Area 7 has been blocked by the piled overburden. There is no record of the lessee requesting approval to mine in this area. See photographs # 9, 10 & 11.

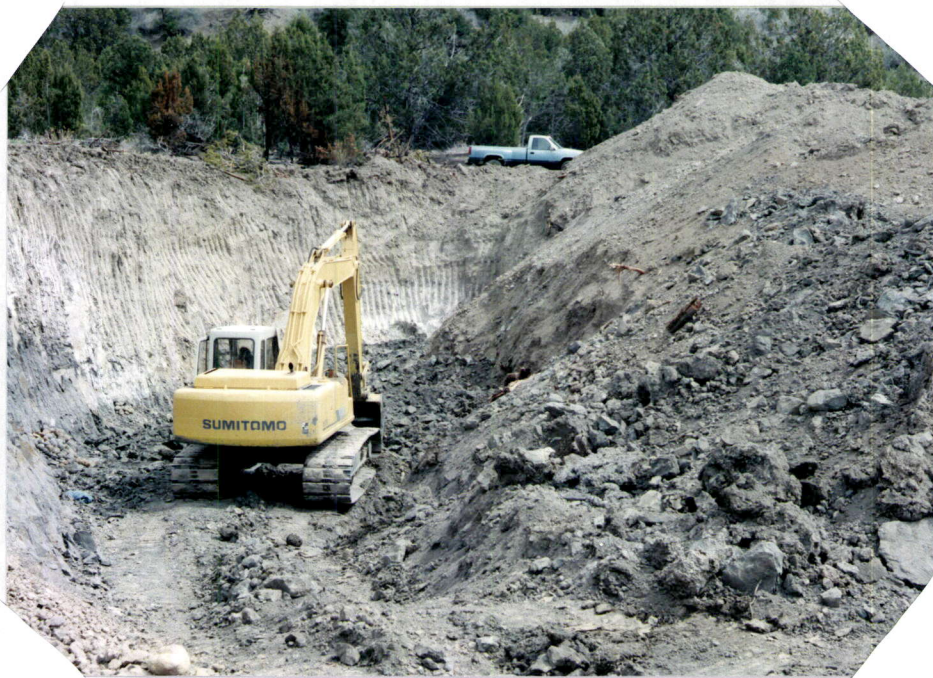
Photo # 8. Looking southeast into the pit created by Joseph M. Caruso. Mr. Caruso was actively mining at the time of the inspection. The area of disturbance is approximatley .10 acre.

Area 6: Joseph M. (Mike) Caruso who holds a 50% interest in lease ML 26996, which encompasses the NE $\frac{1}{4}$ NE $\frac{1}{4}$ of section 36, was conducting an excavation on the lease lands near the northeast corner of section 36 at the time of this inspection. The disturbance encompasses an area of approximately .10 acre. See photo # 8 of this report. There is no record that Mr. Caruso informed the Trust Lands Administration or the Division of Oil, Gas and Mining that he was going to commence with this excavation. See photograph # 8.

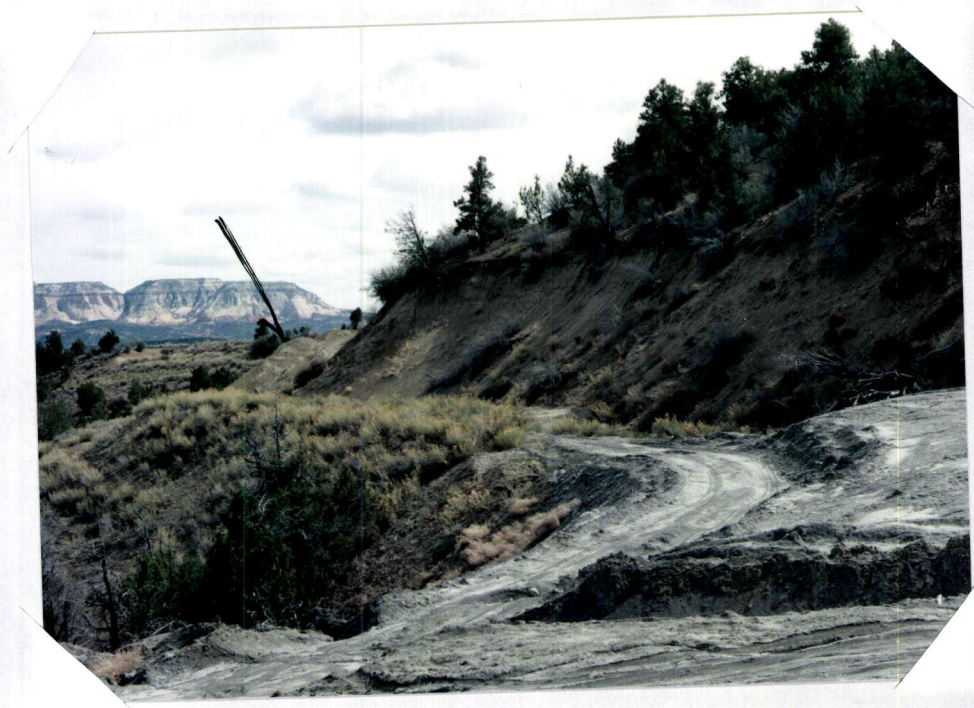
Photo # 9. Looking south from Area 5 onto an old road that had been regraded to provide access to the new excavation at Area 7. The arrow shows the pile of overburden that is found at the north end the excavation at Area 7.

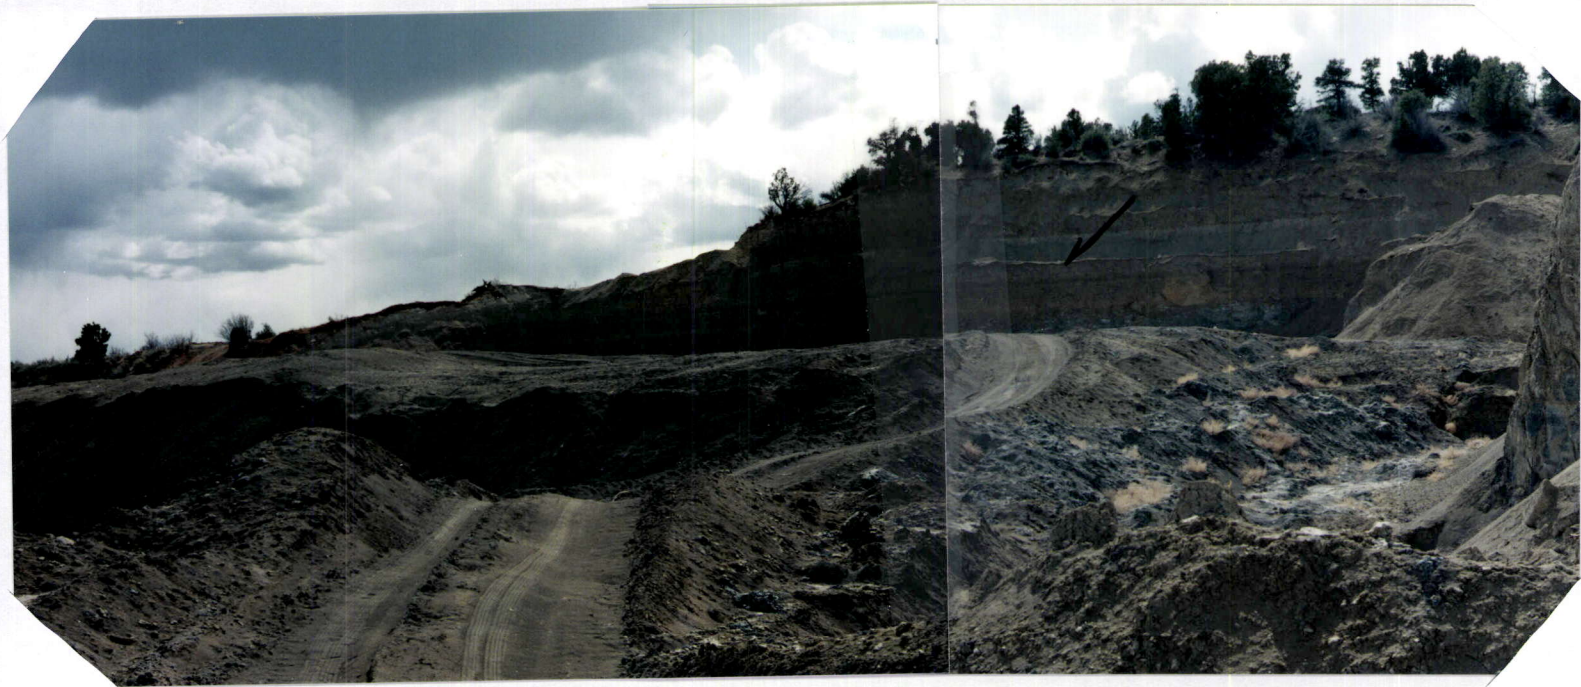
Photo # 11. Looking southwest onto the center of the excavation on Area 7. The high wall indicated by the arrow is the same high wall as shown by arrow # 1 in photo # 10.

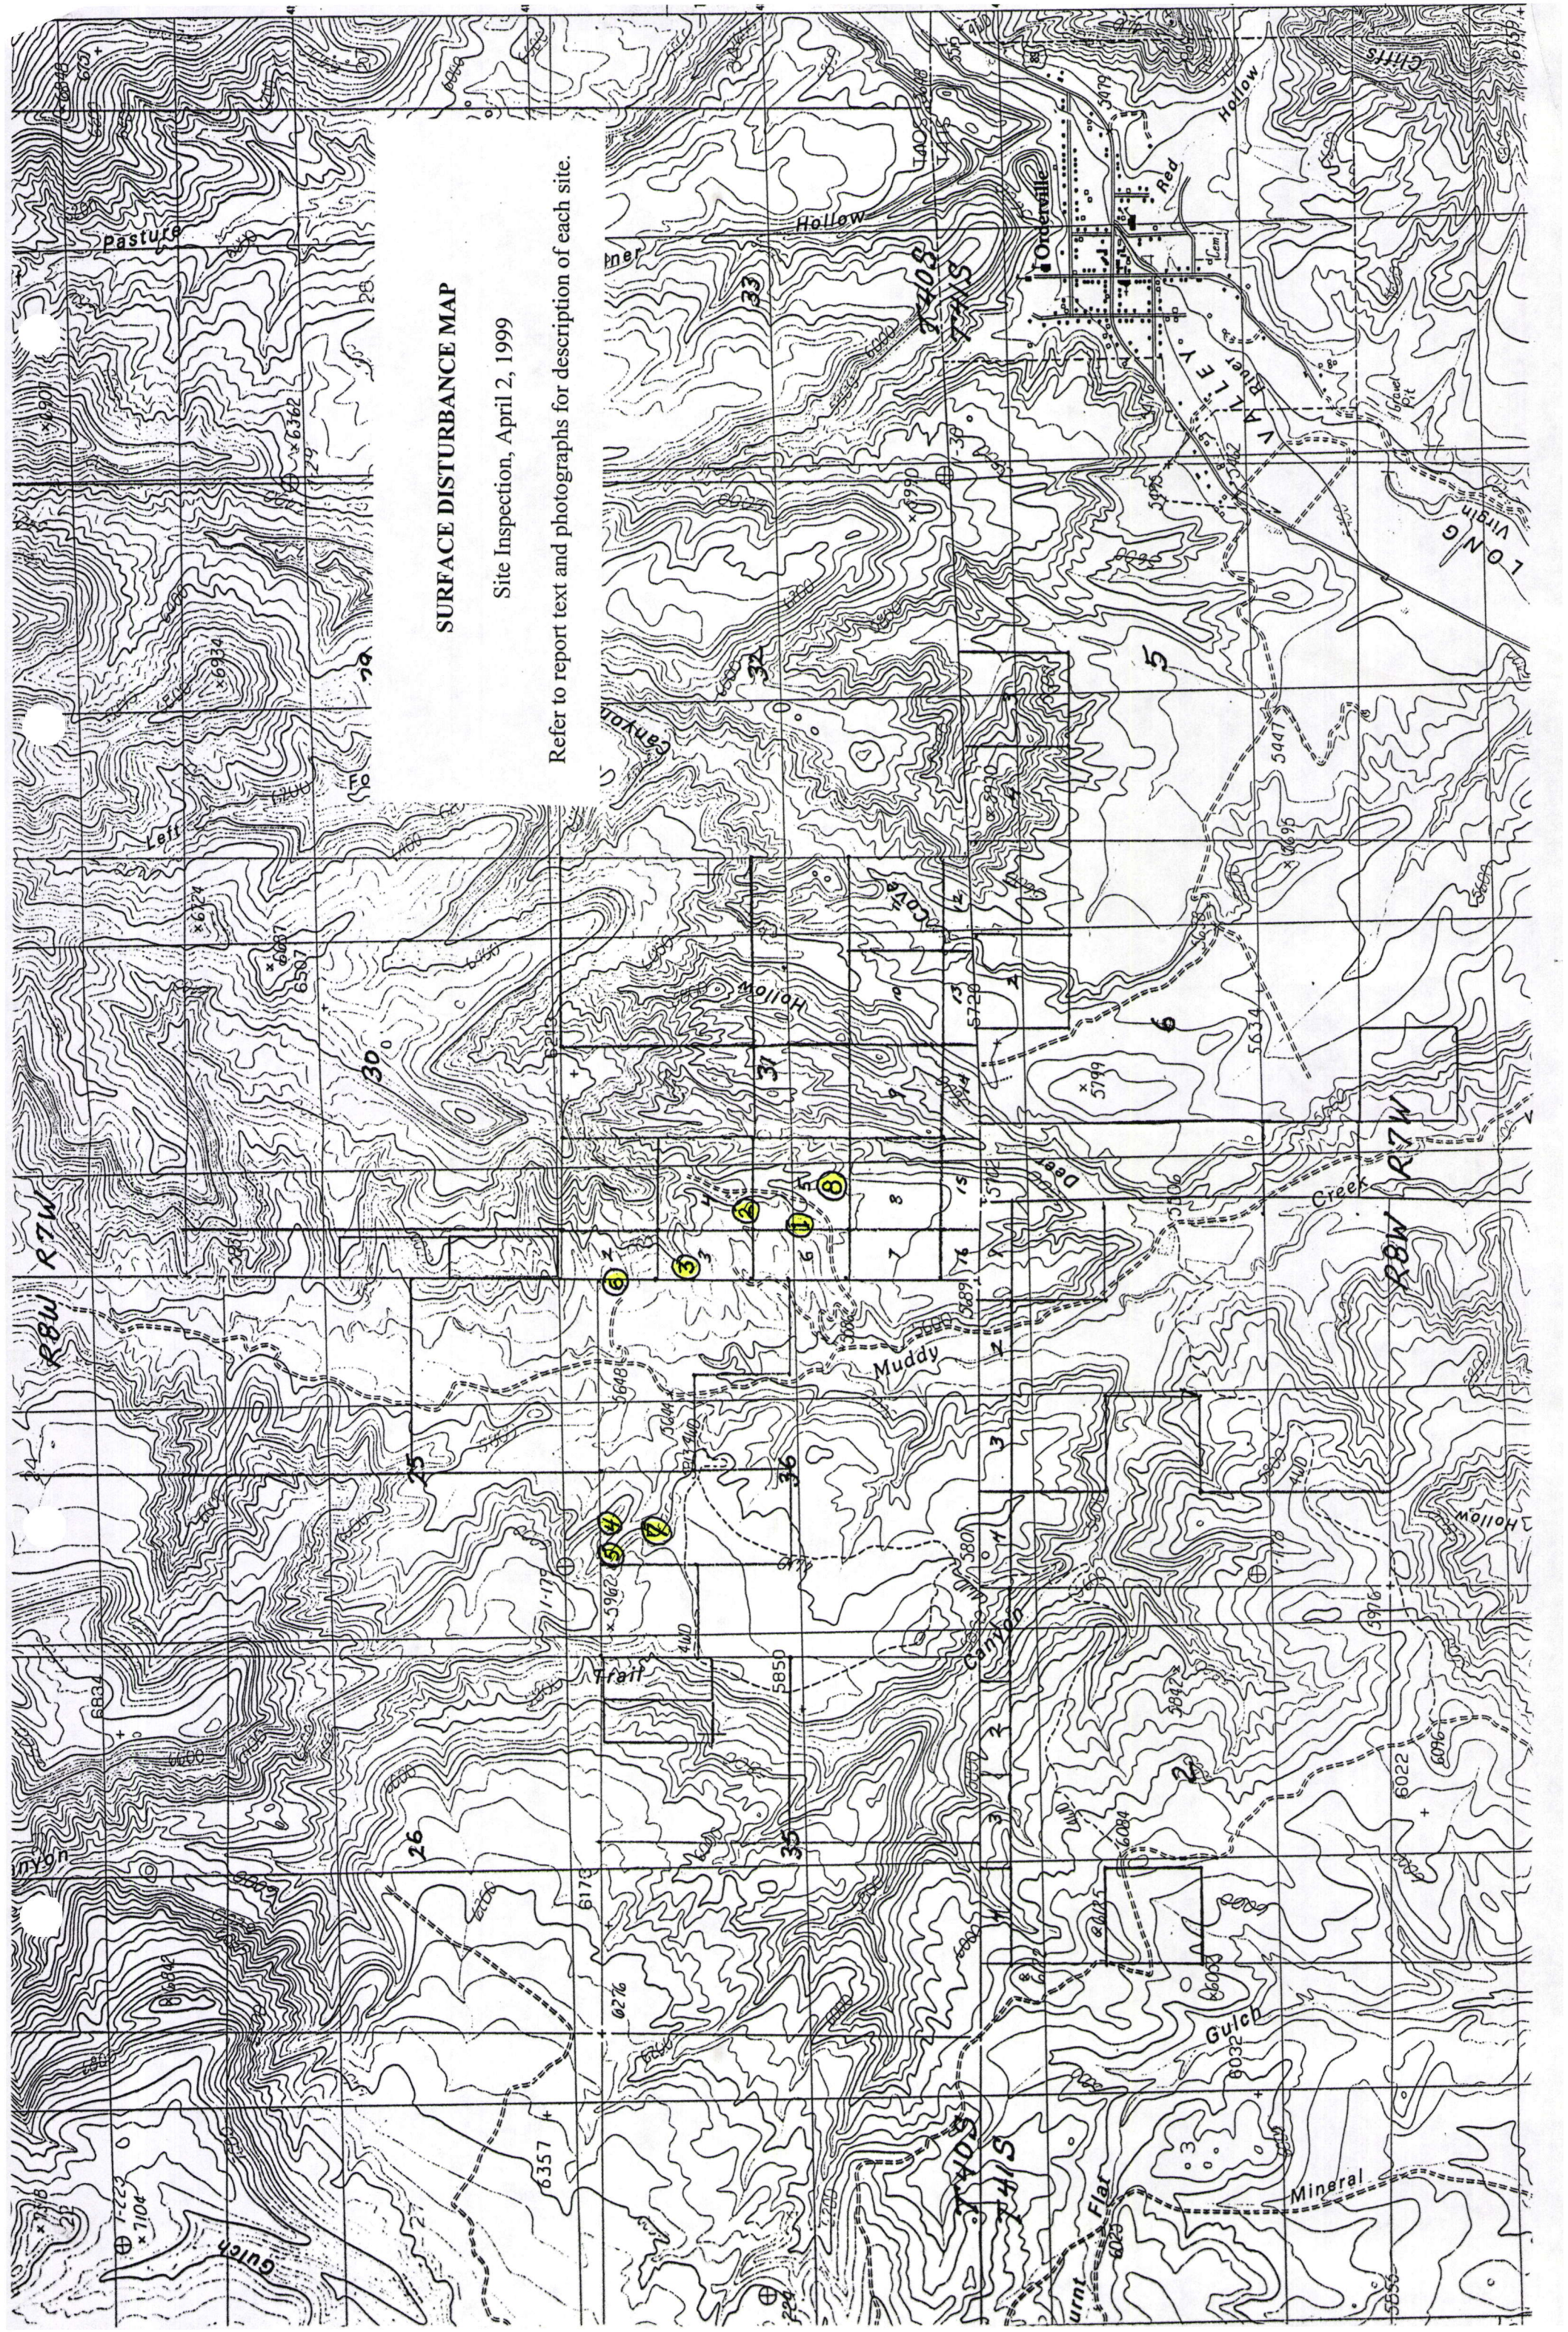
SURFACE DISTURBANCE MAP

Site Inspection, April 2, 1999

Refer to report text and photographs for description of each site.
